Test Report

REPORT NUMBER:
0306/792934

**TEKNOLOGISK
INSTITUT**

SUBJECT: Two built-up walls, each measuring approx. 100 x 100 cm, have been supplied. A test specimen has been installed in each wall panel.

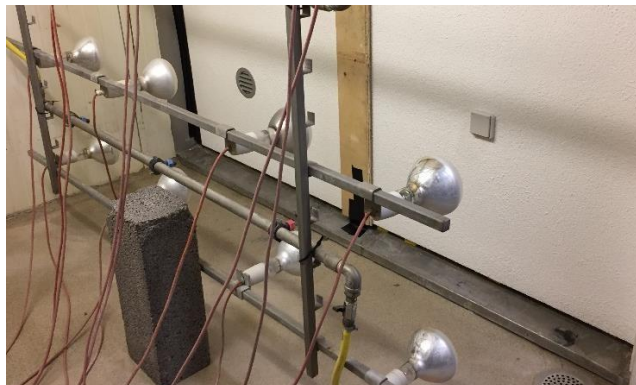
Photo 5 – Specimens during set-up for climate ageing test

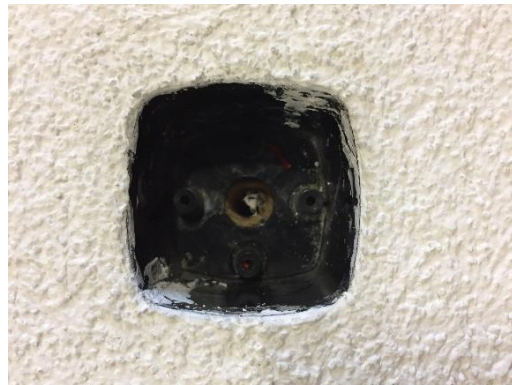
The outlet box behind it shows no immediate damage after testing, and no damage is seen on the rendered area around the socket. See Photo 7.

Photo 7 – Built-in socket and transition to wall – after test

It is believed that the fitting of the socket itself is OK and that the rendered part around the socket has not been damaged by the test.
