Test Report

REPORT NUMBER:
0306/792934

**TEKNOLOGISK
INSTITUT**

SUBJECT: Two built-up walls, each measuring approx. 100 x 100 cm, have been supplied. A test specimen has been installed in each wall panel.

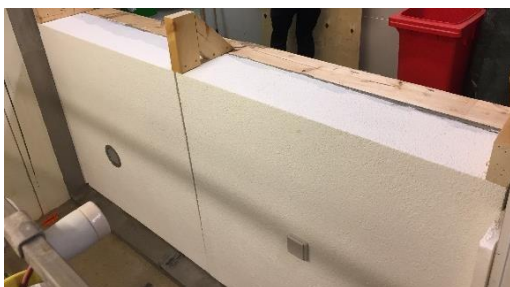
Photo 3 - Specimens from exposed side

On completion of the climate ageing, visual inspection (non-destructive assessment) of the test specimens was performed from both sides. During this visual inspection, no damage was observed. The constructions were further examined by touching critical points around the test specimens to ascertain whether the surfaces were still intact. It was ascertained that the surfaces were intact.

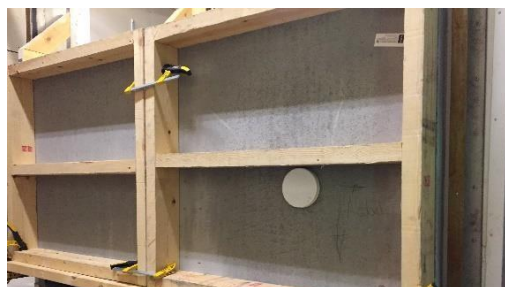
Photo 4 - Specimens from non-exposed side
